LANDSLIDES AND RELATED FEATURES

OF THE LAKE CITY, TENN. QUADRANGLE

by
Roger E. Thomas and Alfred R. Taylor

U.S. Geological Survey
OPEN FILE MAP 82-653(B-15)

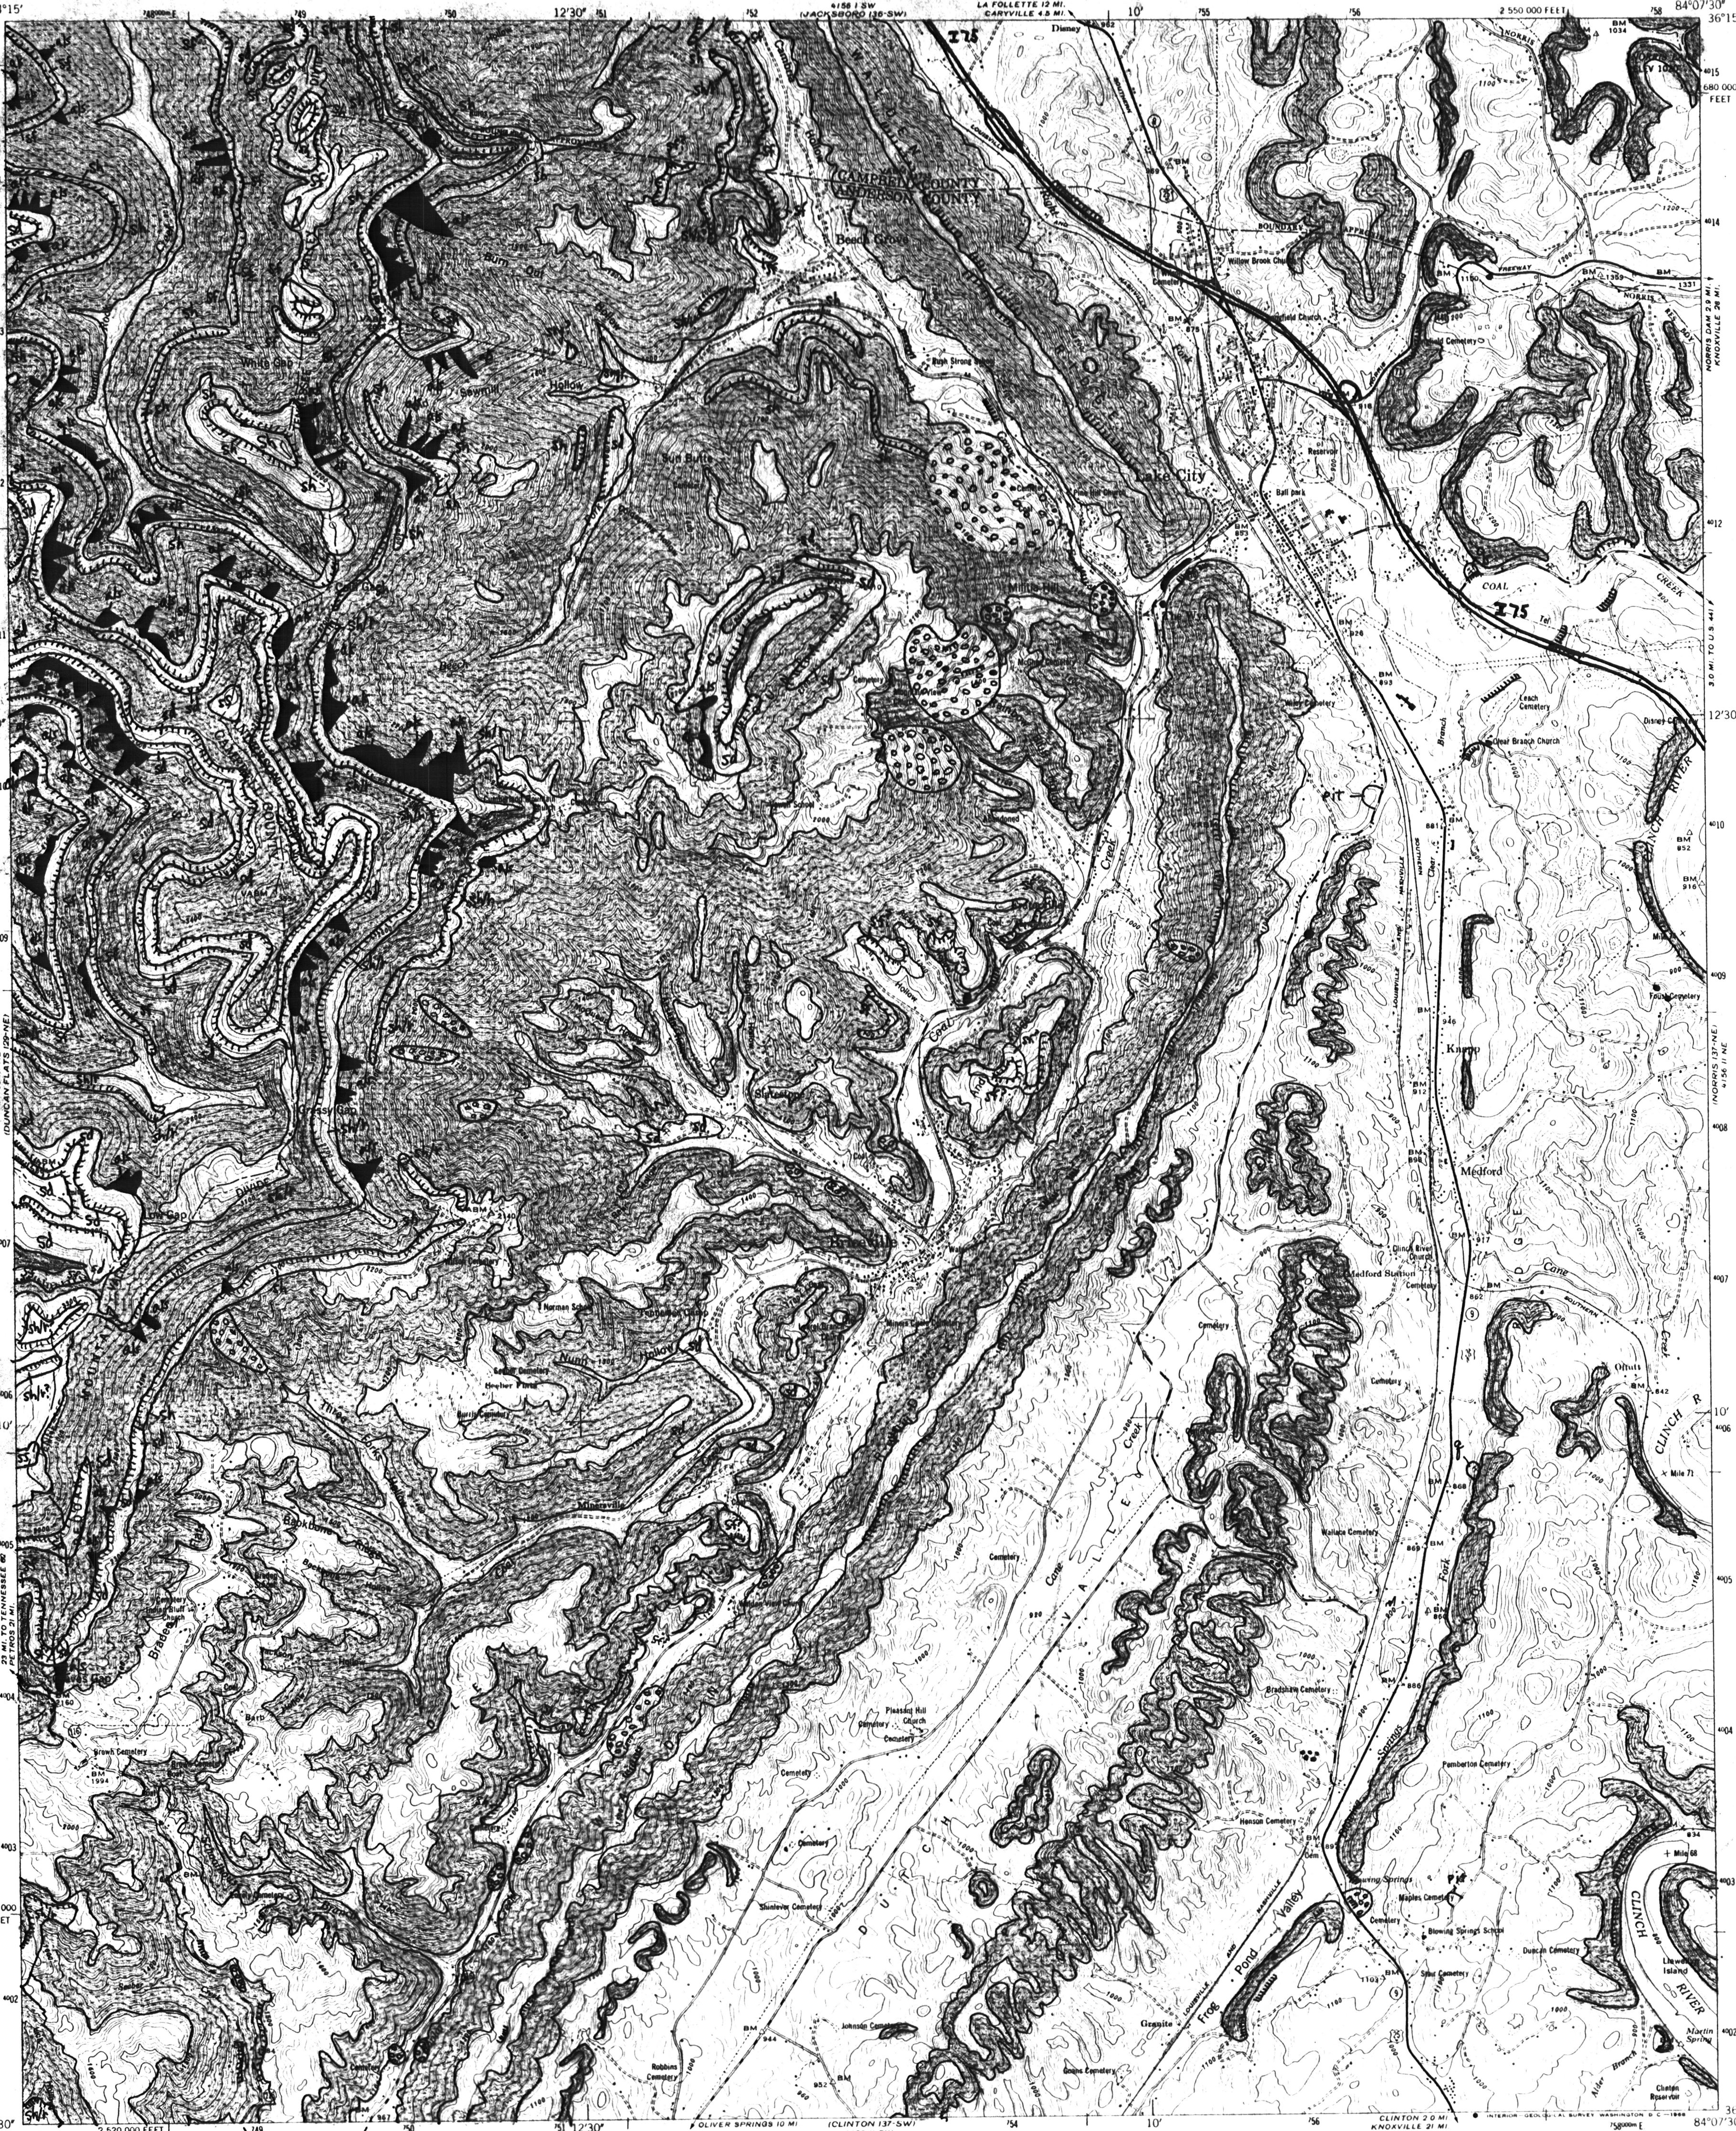
ACTIVE OR RECENTLY ACTIVE LANDSLIDE
Complex landslide composed of earthflow, debris
slide, earth and rock slump. Identified from
historical records, and from scars, debris and
other field evidence. Ground extremely unstable;
sliding accelerated by excavation, loading and
changes in drainage conditions. May include
areas with several active slides too small to
be shown separately. Questioned where doubtful.

OLD LANDSLIDE
Area of extensive hummocky ground caused by
earthflow and earth and rock slump. Lacks
clear evidence of active sliding. Relatively
stable in natural, undisturbed state,
generally not affected by small structures properly
sited in areas away from the edge of the toe;
can be reactivated by extensive, rapid excava-
tion, loading, and changes in ground water and
surface water conditions. Area of old landslide
probably includes recent ones not identified
from field evidence or otherwise documented.
Upslope boundary of landslide generally defined
by modified scarp, but downslope (toe) may be
gradational and not well defined. Questioned
where doubtful.

COMBINATION LANDSLIDE
Area of recent and old slides in which
individual slides are not identified.

COLLUVIAL SLOPE
Valley wall along major streams with slope as
steep as 40° (85%); stony, clayey silt soil up
to 50 ft. (15 m) thick; commonly buttressed by
a terrace or bench at the toe of the slope; very
susceptible to sliding by cutting of toe area,
removal of terrace or bench, and overloading;
slide commonly activated without apparent cause.

COLLUVIAL SLOPES WITH LANDSLIDES
Landslides too small or obscure to map
individually.

**AREAS SUSCEPTIBLE TO DEBRIS FLOWS AND DEBRIS
AVALANCHES**
Primarily shallow, narrow ravines and chutes with
accumulation of stony colluvium generally 10 ft.
(3 m) or less in thickness; susceptible to rapid
movement during intense rainfall. Most ravines
and chutes designated show evidence of former
debris flows and avalanches.

AREAS SUSCEPTIBLE TO ROCKFALL
Steep, locally vertical, natural and man-made
slopes and cliffs, 15 ft. (4.5 m) or more high;
formed dominantly of sandstone, limestone, sandy
shale, mudstone and claystone. Interbedded mud-
stone, claystone and shale weather rapidly leaving
sandstone and limestone rock faces unsupported.

SOIL AND ROCK SUSCEPTIBLE TO LANDSLIDING
Soil and rock similar to that involved in land-
slides elsewhere in map area; primarily areas
underlain by claystone, mudstone and shale
associated with other rock types. Rock weathers
rapidly on exposure forming clayey soil highly
susceptible to sliding. Includes coves (U-shaped,
shallow valleys) containing thick layers of clayey
soil that are very susceptible to sliding where
excavation breaks continuity of slope and where
overloaded by artificial fill.

AREAS LEAST PRONE TO LANDSLIDES
Map areas in which no patterns or symbols are shown;
primarily valley floors, ridge tops and broad
benches; modification by excavation and fill may
lead to local landslides.
